# Tree Inventory Report

Dublin City Council

29 November 2022

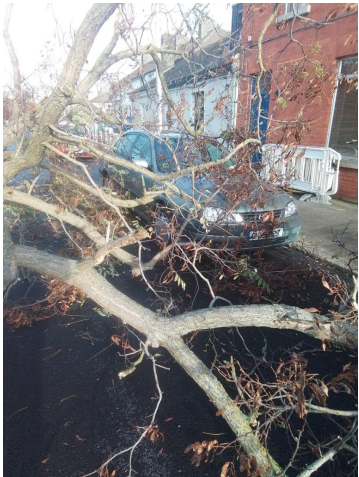
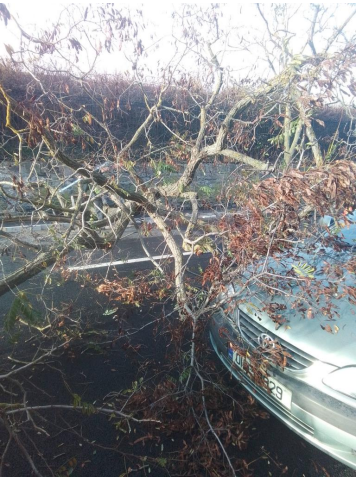
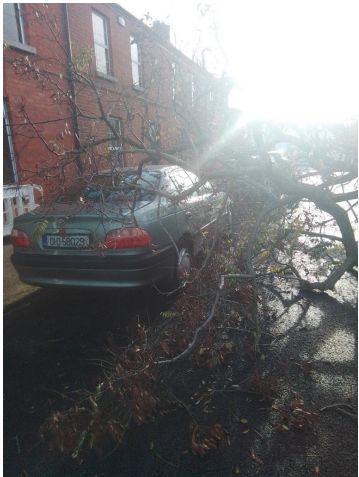
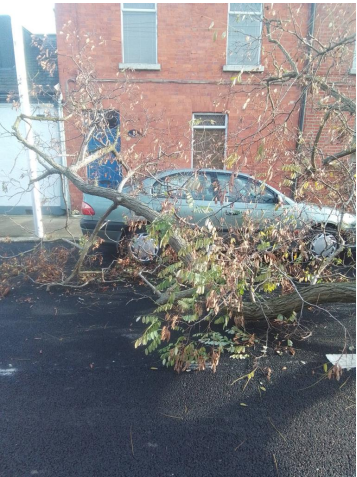
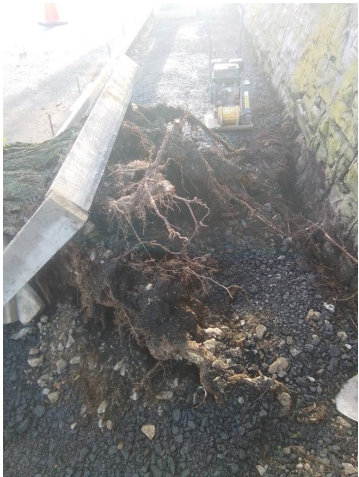
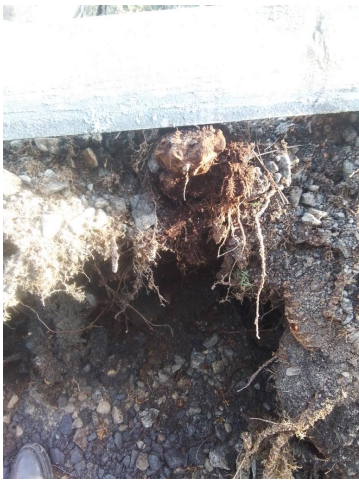
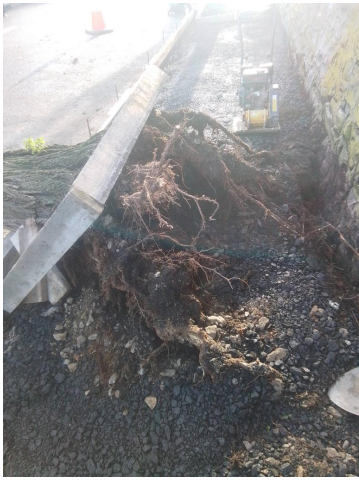
Inventory	
Surveyor	Iudovic.beaumont
Inspection Date	29-Nov-2022
Trunk Type	Single
Age	Middle Aged (Within second third of lifespan)
Condition	Felled
Proximity	
Street	West Road
Stem Diameter	36cm-40cm (@1.5m)
Spread	3-6m (Diameter)
Height	05 to 10m
Category	U - Trees with serious defect/decline
Committee	
Site	Tarmac

Comment	
Surveyor	ludovic.beaumont
Comment Date	29-Nov-2022
Comment	Main root on wall side had totally decayed.

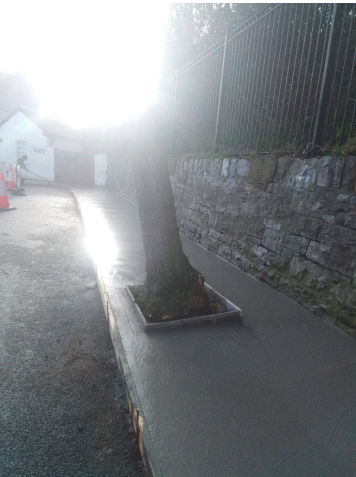
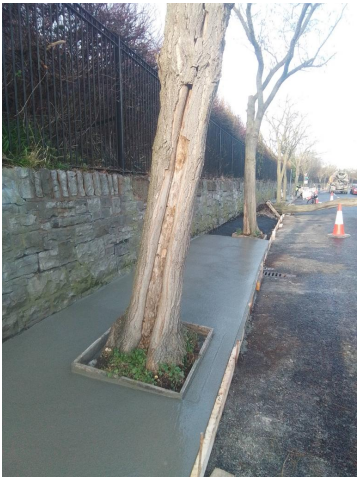
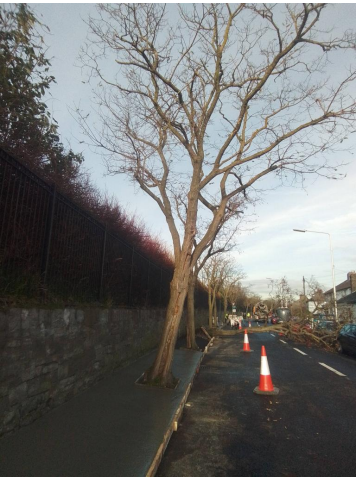
Inventory	
Surveyor	Iudovic.beaumont
Inspection Date	29-Nov-2022
Trunk Type	Single
Age	Middle Aged (Within second third of lifespan)
Condition	Poor (Low Vitality/Extensive Defects)
Proximity	
Building Number	78
Street	West Road
Stem Diameter	36cm-40cm (@1.5m)
Spread	3-6m (Diameter)
Height	05 to 10m
Category	U - Trees with serious defect/decline
Committee	
Site	Tarmac

Considerations	
Consideration	t. Cavity/Decay Stem

Considerations	
Consideration	t. Dead wood

Considerations	
Consideration	s. Unsuitable for Location

Considerations	
Consideration	t. Excessive lean

Requirements	
Date Added	29-Nov-2022
Priority	3b. (within 14 working days)
Requirement Type	Tree Removal
Requirement Option	
Requirement Info

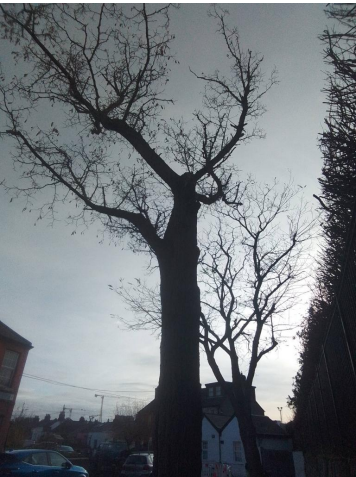
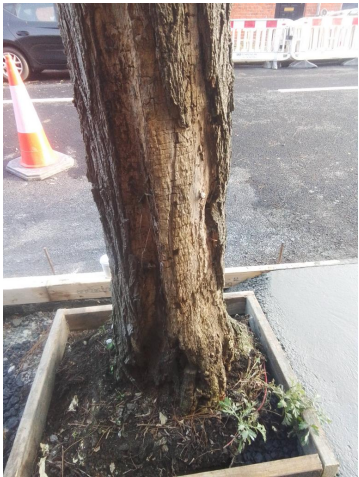
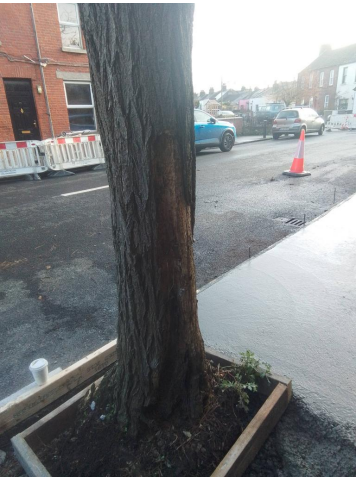
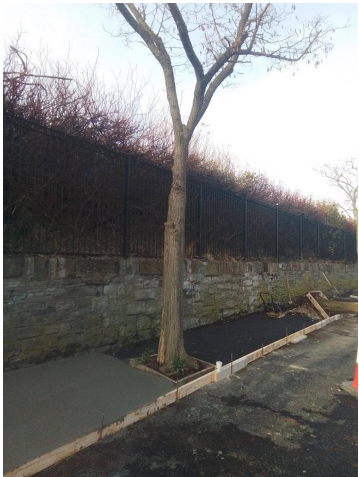
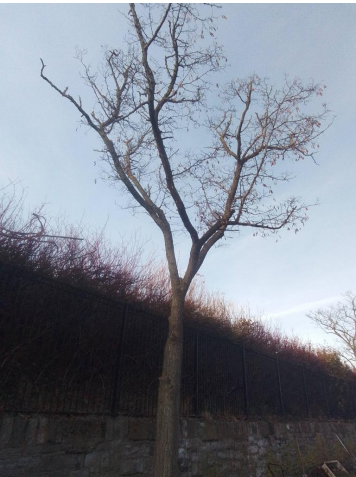
Inventory	
Surveyor	Iudovic.beaumont
Inspection Date	29-Nov-2022
Trunk Type	Single
Age	Middle Aged (Within second third of lifespan)
Condition	Poor (Low Vitality/Extensive Defects)
Proximity	
Building Number	76
Street	West Road
Stem Diameter	36cm-40cm (@1.5m)
Spread	3-6m (Diameter)
Height	05 to 10m
Category	U - Trees with serious defect/decline
Committee	
Site	Tarmac

Considerations	
Consideration	t. Unstable rootplate

Considerations	
Consideration	t. Cavity/Decay Stem

Considerations	
Consideration	t. Dead wood

Considerations	
Consideration	s. Unsuitable for Location

Requirements	
Date Added	29-Nov-2022
Priority	3b. (within 14 working days)
Requirement Type	Tree Removal
Requirement Option	
Requirement Info

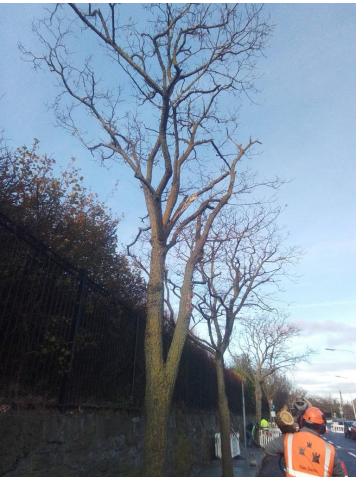
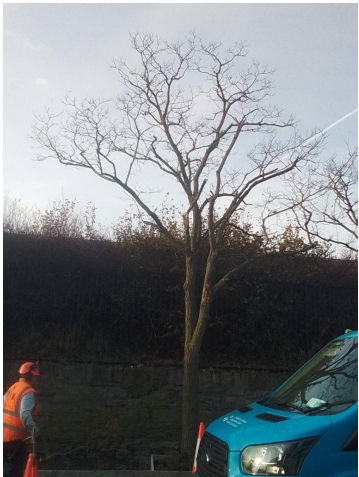
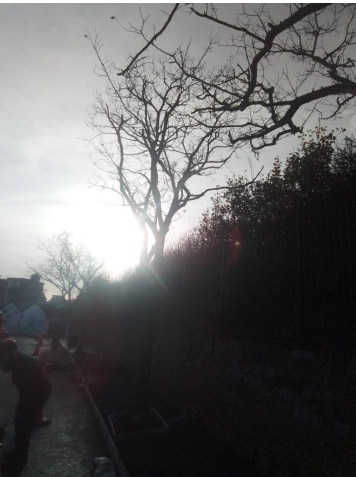
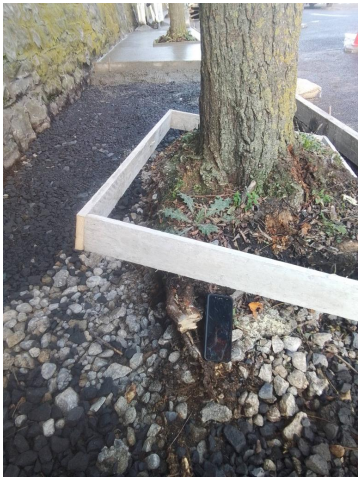
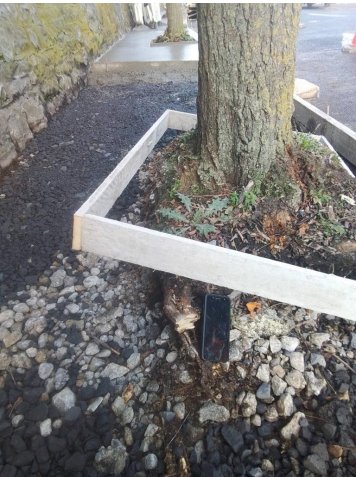
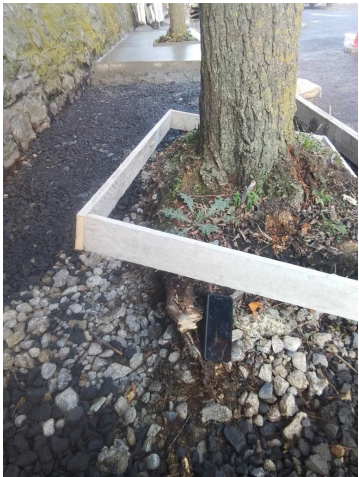
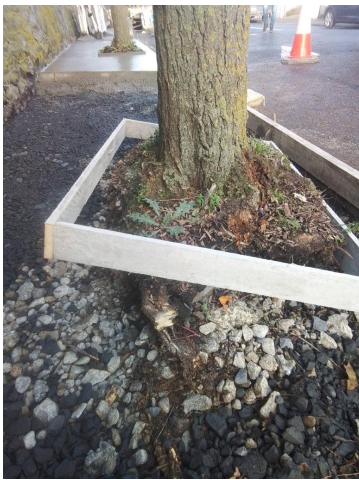
Inventory	
Surveyor	ludovic.beaumont
Inspection Date	29-Nov-2022
Trunk Type	Single
Age	Middle Aged (Within second third of lifespan)
Condition	Poor (Low Vitality/Extensive Defects)
Proximity	
Building Number	74
Street	West Road
Stem Diameter	36cm-40cm (@1.5m)
Spread	3-6m (Diameter)
Height	05 to 10m
Category	U - Trees with serious defect/decline
Committee	
Site	Tarmac

Considerations	
Consideration	s. Unsuitable for Location

Considerations	
Consideration	t. Unstable rootplate

Considerations	
Consideration	t. Roots damaged

Considerations	
Consideration	t. Dead wood

Considerations	
Consideration	t. Dieback/Poor foliage

Comment	
Surveyor	ludovic.beaumont
Comment Date	29-Nov-2022
Comment	Damage to roots s ystem

Requirements	
Date Added	29-Nov-2022
Priority	3b. (within 14 working days)
Requirement Type	Tree Removal
Requirement Option	
Requirement Info

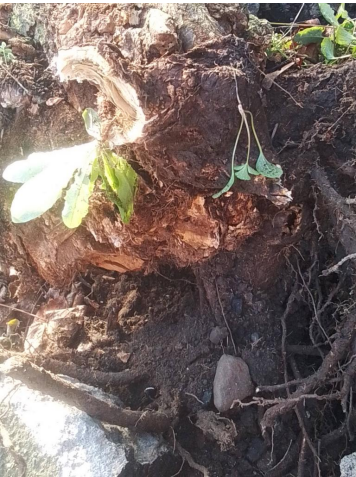
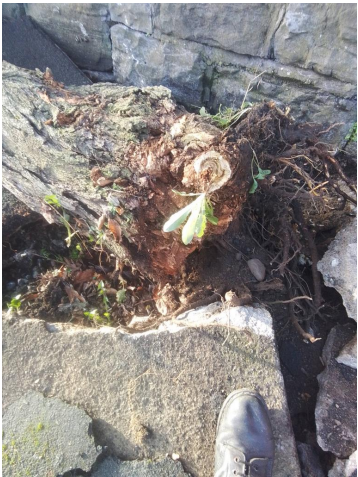
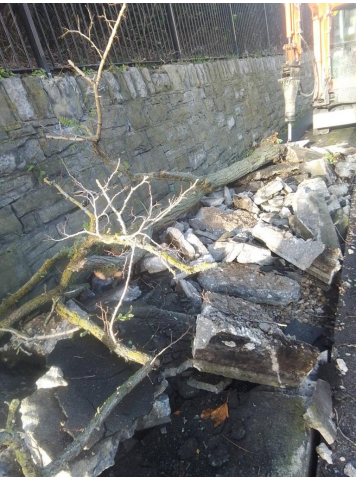
Inventory	
Surveyor	Iudovic.beaumont
Inspection Date	29-Nov-2022
Trunk Type	Single
Age	Middle Aged (Within second third of lifespan)
Condition	Felled
Proximity	OPPOSITE
Building Number	56
Street	West Road
Stem Diameter	36cm-40cm (@1.5m)
Spread	3-6m (Diameter)
Height	05 to 10m
Category	U - Trees with serious defect/decline
Committee	
Site	Tarmac

Considerations	
Consideration	t. Unstable rootplate

Considerations	
Consideration	s. Unsuitable for Location

Comment	
Surveyor	ludovic.beaumont
Comment Date	29-Nov-2022
Comment	Tree was moving when slightly pushed. Base entirely decayed (brown rot).

Requirements	
Date Added	29-Nov-2022
Priority	3b. (within 14 working days)
Requirement Type	Tree Removal
Requirement Option	
Requirement Info

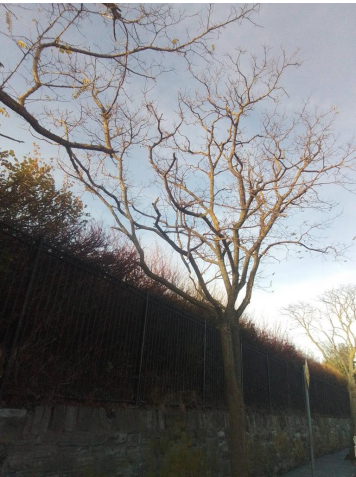
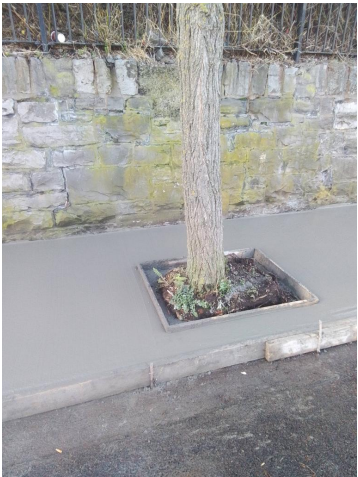
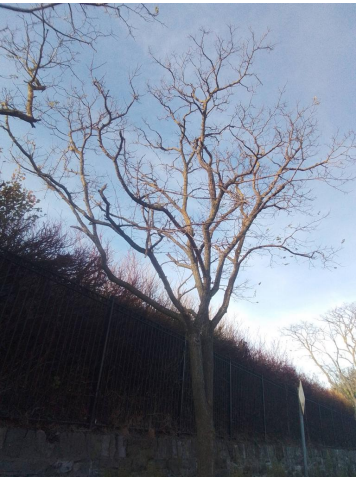
Inventory	
Surveyor	Iudovic.beaumont
Inspection Date	29-Nov-2022
Trunk Type	Single
Age	Middle Aged (Within second third of lifespan)
Condition	Poor (Low Vitality/Extensive Defects)
Proximity	OPPOSITE
Building Number	73
Street	WEST ROAD
Stem Diameter	21cm-25cm (@1.5m)
Spread	3-6m (Diameter)
Height	05 to 10m
Category	U - Trees with serious defect/decline
Committee	
Site	Pavement

Considerations	
Consideration	t. Dead wood

Considerations	
Consideration	s. Unsuitable for Location

Considerations	
Consideration	t. Dieback/Poor foliage

Considerations	
Consideration	t. Hangers in Canopy

Considerations	
Consideration	t. Unstable rootplate

Requirements	
Date Added	29-Nov-2022
Priority	3b. (within 14 working days)
Requirement Type	Tree Removal
Requirement Option	
Requirement Info

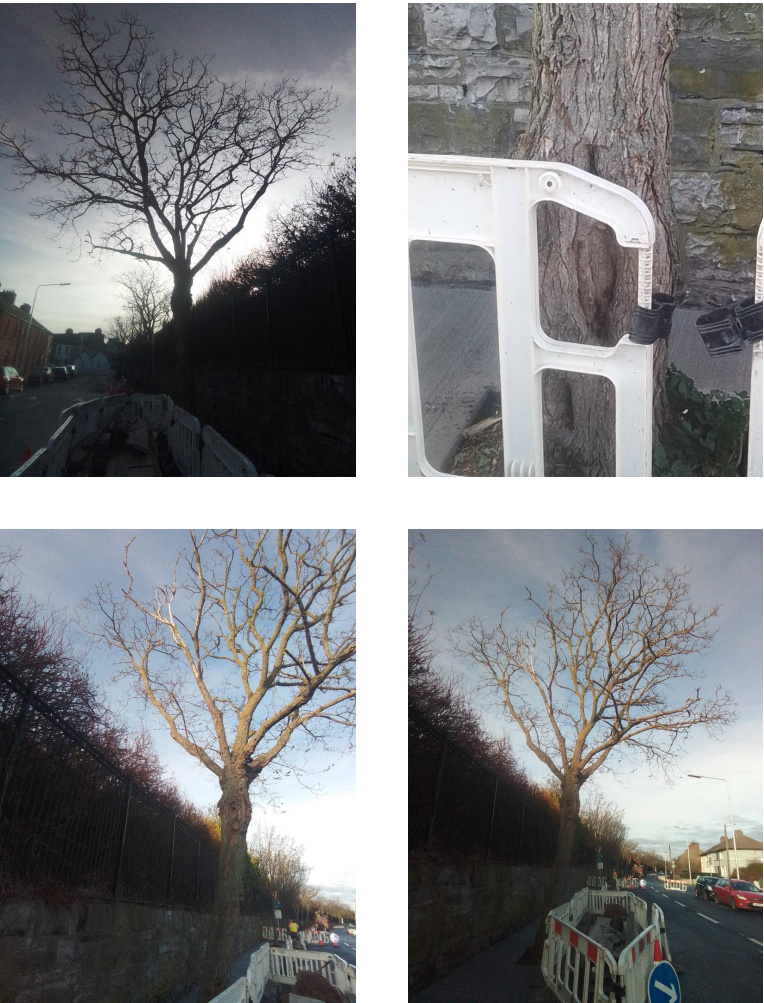
Inventory	
Surveyor	Iudovic.beaumont
Inspection Date	29-Nov-2022
Trunk Type	Single
Age	Middle Aged (Within second third of lifespan)
Condition	Poor (Low Vitality/Extensive Defects)
Proximity	OPPOSITE
Building Number	71
Street	West Road
Stem Diameter	36cm-40cm (@1.5m)
Spread	6-9m (Diameter)
Height	05 to 10m
Category	U - Trees with serious defect/decline
Committee	
Site	Pavement

Considerations	
Consideration	t. Dead wood

Considerations	
Consideration	s. Unsuitable for Location

Considerations	
Consideration	t. Cavity/Decay Stem

Considerations	
Consideration	t. Dieback/Poor foliage

Considerations	
Consideration	t. Unstable rootplate

Requirements	
Date Added	29-Nov-2022
Priority	3b. (within 14 working days)
Requirement Type	Tree Removal
Requirement Option	
Requirement Info

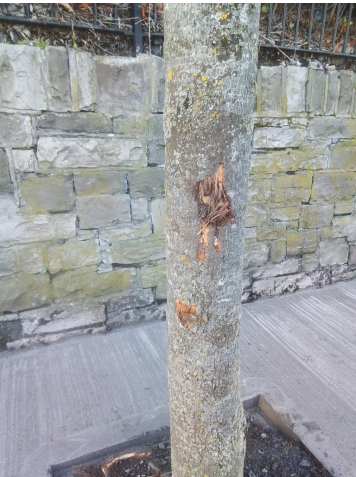
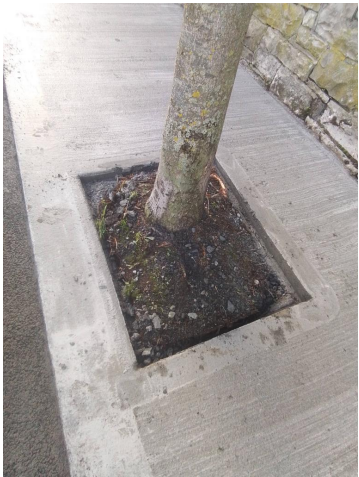
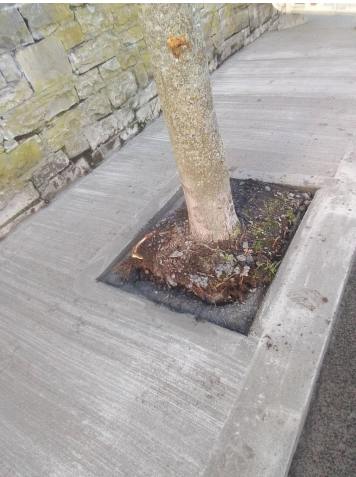
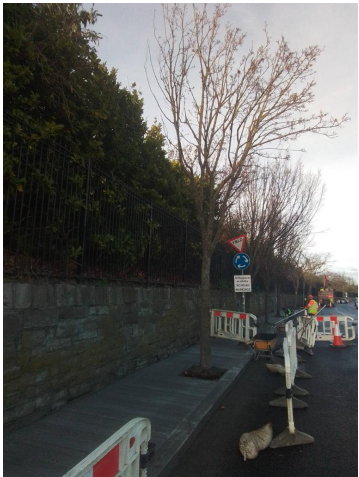
Inventory	
Surveyor	Iudovic.beaumont
Inspection Date	29-Nov-2022
Trunk Type	Single
Age	Young (Within first third of life span)
Condition	Poor (Low Vitality/Extensive Defects)
Proximity	OPPOSITE
Building Number	68
Street	West Road
Stem Diameter	21cm-25cm (@1.5m)
Spread	3-6m (Diameter)
Height	05 to 10m
Category	U - Trees with serious defect/decline
Committee	
Site	Pavement

Considerations	
Consideration	t. Dead wood

Considerations	
Consideration	s. Unsuitable for Location

Considerations	
Consideration	t. Unstable rootplate

Requirements	
Date Added	29-Nov-2022
Priority	3b. (within 14 working days)
Requirement Type	Tree Removal
Requirement Option	
Requirement Info

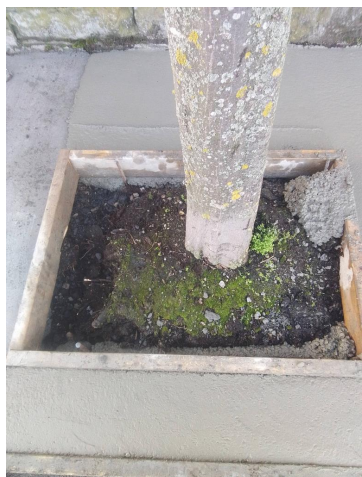
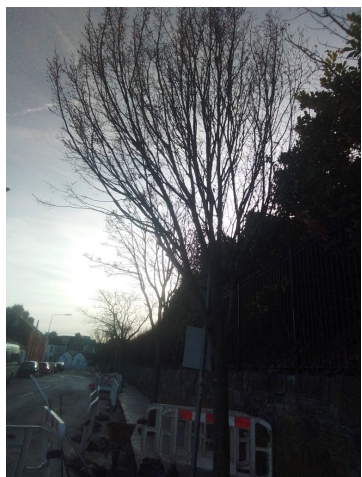
Unique ID: 09MH  
Carpinus betulus Fastigiata

Inventory	
Surveyor	Iudovic.beaumont
Inspection Date	29-Nov-2022
Trunk Type	Single
Age	Young (Within first third of life span)
Condition	Poor (Low Vitality/Extensive Defects)
Proximity	
Street	West Road
Stem Diameter	21cm-25cm (@1.5m)
Spread	3-6m (Diameter)
Height	05 to 10m
Category	U - Trees with serious defect/decline
Committee	
Site	Pavement

Considerations	
Consideration	t. Unstable rootplate

Considerations	
Consideration	t. Dead wood

Considerations	
Consideration	s. Unsuitable for Location

Requirements	
Date Added	29-Nov-2022
Priority	3b. (within 14 working days)
Requirement Type	Tree Removal
Requirement Option	
Requirement Info

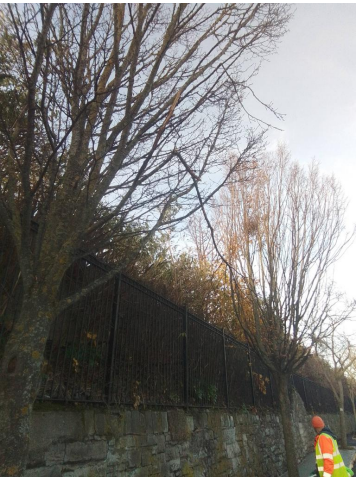
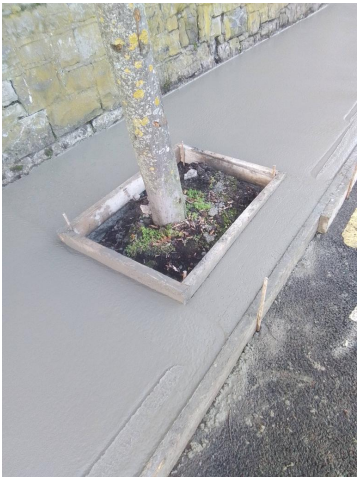
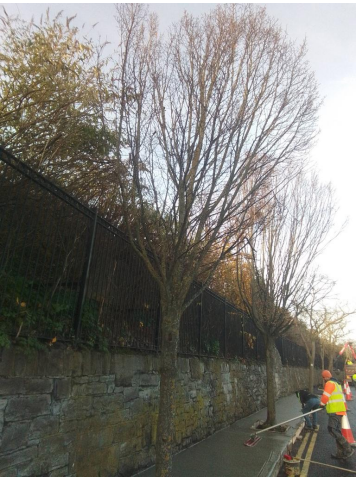
Inventory	
Surveyor	Iudovic.beaumont
Inspection Date	29-Nov-2022
Trunk Type	Single
Age	Young (Within first third of life span)
Condition	Poor (Low Vitality/Extensive Defects)
Proximity	
Building Number	Roundabout
Street	West Road
Stem Diameter	21cm-25cm (@1.5m)
Spread	3-6m (Diameter)
Height	05 to 10m
Category	U - Trees with serious defect/decline
Committee	
Site	Pavement

Considerations	
Consideration	t. Unstable rootplate

Considerations	
Consideration	s. Unsuitable for Location

Requirements	
Date Added	29-Nov-2022
Priority	3b. (within 14 working days)
Requirement Type	Tree Removal
Requirement Option	
Requirement Info

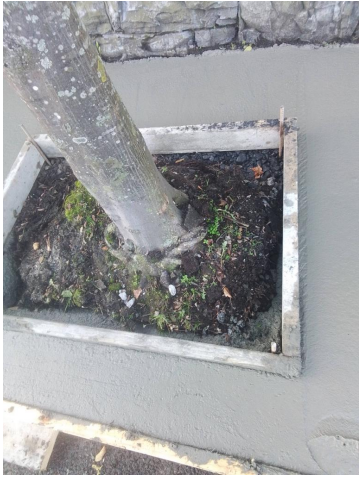
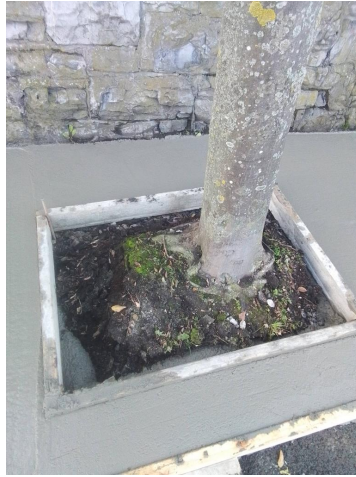
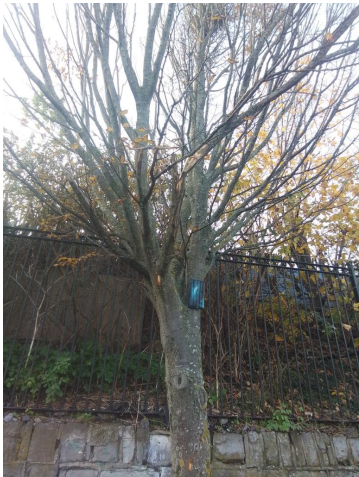
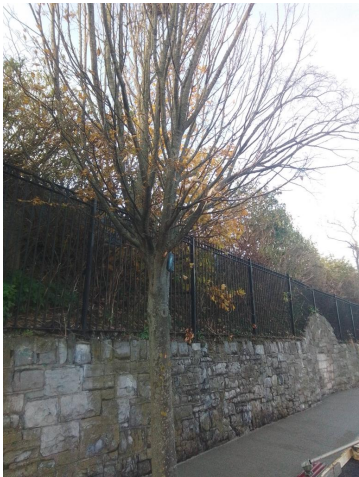
Unique ID: 09MK  
*Carpinus betulus* Fastigiata

Inventory	
Surveyor	ludovic.beaumont
Inspection Date	29-Nov-2022
Trunk Type	Single
Age	Young (Within first third of life span)
Condition	Poor (Low Vitality/Extensive Defects)
Proximity	
Building Number	ROUNDAABOUT
Street	West Road
Stem Diameter	21cm-25cm (@1.5m)
Spread	3-6m (Diameter)
Height	05 to 10m
Category	U - Trees with serious defect/decline
Committee	
Site	Pavement

Considerations	
Consideration	t. Unstable rootplate

Considerations	
Consideration	t. Crack on Limb

Considerations	
Consideration	s. Unsuitable for Location

Requirements	
Date Added	29-Nov-2022
Priority	3b. (within 14 working days)
Requirement Type	Tree Removal
Requirement Option	
Requirement Info

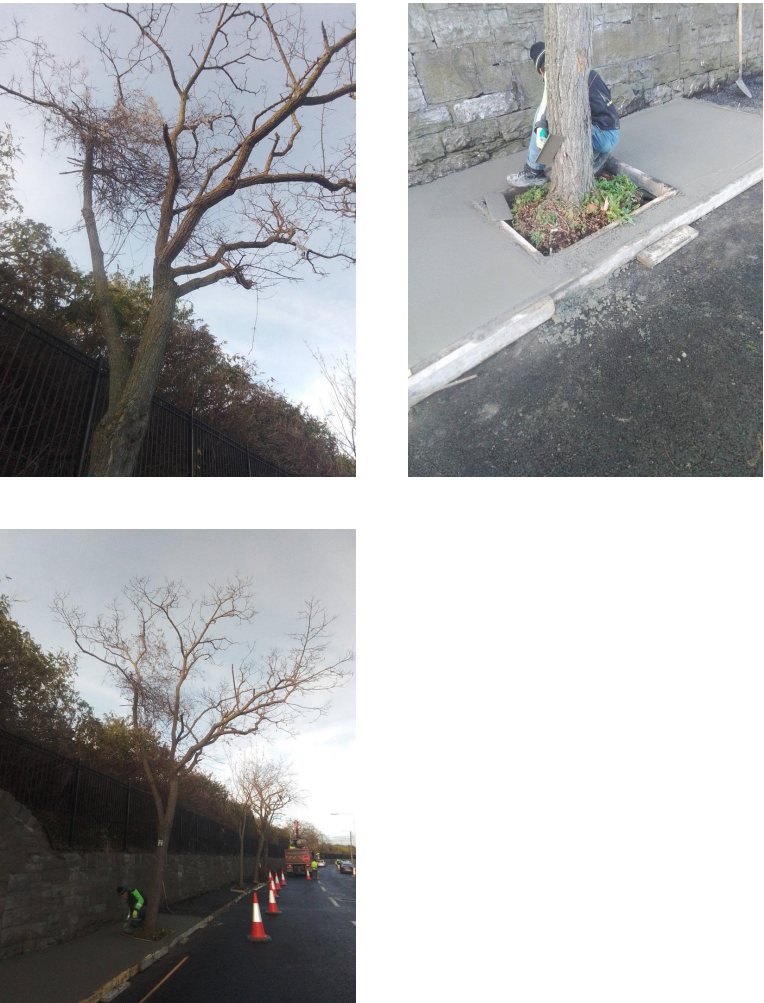
Inventory	
Surveyor	ludovic.beaumont
Inspection Date	29-Nov-2022
Trunk Type	Single
Age	Middle Aged (Within second third of lifespan)
Condition	Poor (Low Vitality/Extensive Defects)
Proximity	
Building Number	66
Street	West Road
Stem Diameter	21cm-25cm (@1.5m)
Spread	3-6m (Diameter)
Height	05 to 10m
Category	U - Trees with serious defect/decline
Committee	
Site	Pavement

Considerations	
Consideration	t. Dead wood

Considerations	
Consideration	t. Cavity/Decay Stem

Considerations	
Consideration	t. Unstable rootplate

Considerations	
Consideration	t. Dieback/Poor foliage

Considerations	
Consideration	s. Unsuitable for Location

Requirements	
Date Added	29-Nov-2022
Priority	3b. (within 14 working days)
Requirement Type	Tree Removal
Requirement Option	
Requirement Info

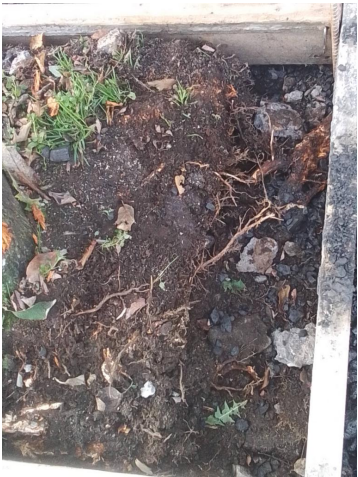
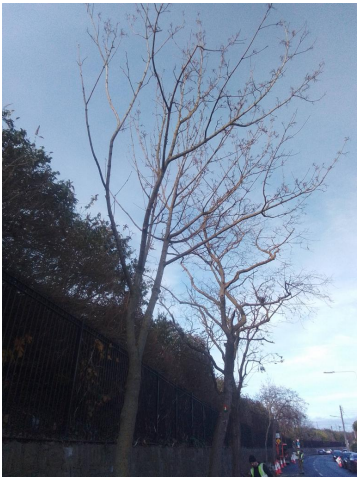
Inventory	
Surveyor	Iudovic.beaumont
Inspection Date	29-Nov-2022
Trunk Type	Single
Age	Young (Within first third of life span)
Condition	Poor (Low Vitality/Extensive Defects)
Proximity	OPPOSITE
Building Number	64
Street	West Road
Stem Diameter	21cm-25cm (@1.5m)
Spread	3-6m (Diameter)
Height	05 to 10m
Category	U - Trees with serious defect/decline
Committee	
Site	Pavement

Considerations	
Consideration	t. Unstable rootplate

Considerations	
Consideration	s. Unsuitable for Location

Requirements	
Date Added	29-Nov-2022
Priority	3b. (within 14 working days)
Requirement Type	Tree Removal
Requirement Option	
Requirement Info

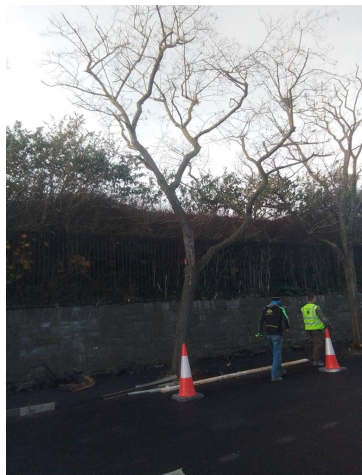
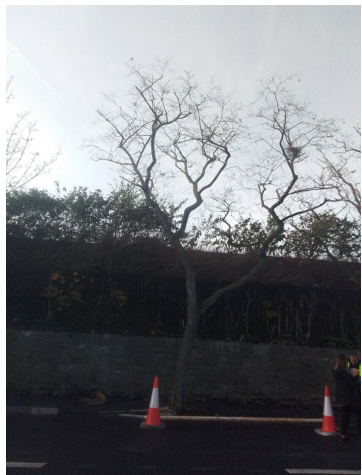
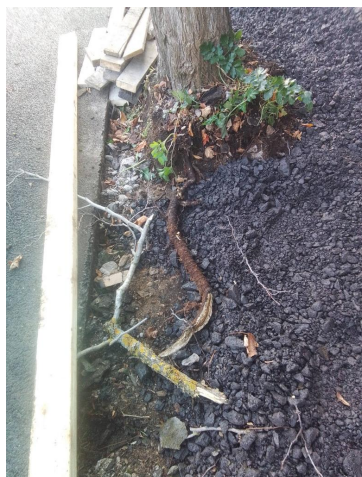
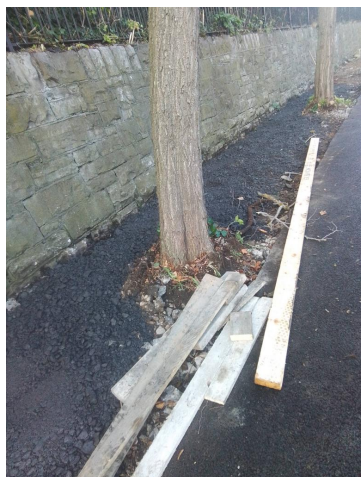
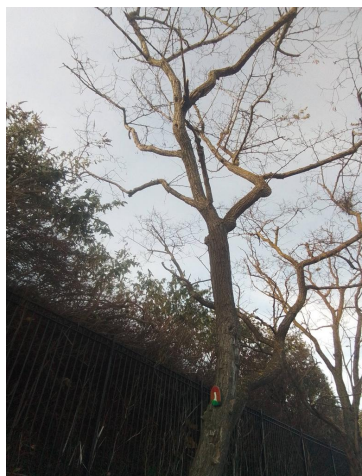
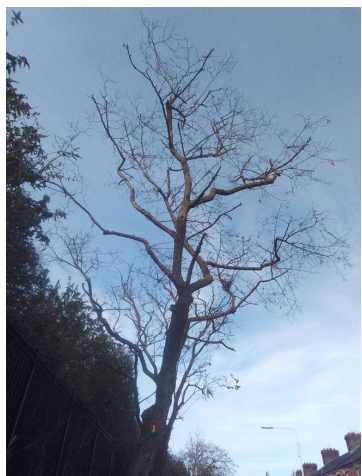
Inventory	
Surveyor	Iudovic.beaumont
Inspection Date	29-Nov-2022
Trunk Type	Single
Age	Young (Within first third of life span)
Condition	Poor (Low Vitality/Extensive Defects)
Proximity	OPPOSITE
Building Number	63 64
Street	West Road
Stem Diameter	21cm-25cm (@1.5m)
Spread	3-6m (Diameter)
Height	05 to 10m
Category	U - Trees with serious defect/decline
Committee	
Site	Pavement

Considerations	
Consideration	t. Unstable rootplate

Considerations	
Consideration	t. Dieback/Poor foliage

Considerations	
Consideration	s. Unsuitable for Location

Requirements	
Date Added	29-Nov-2022
Priority	3b. (within 14 working days)
Requirement Type	Tree Removal
Requirement Option	
Requirement Info

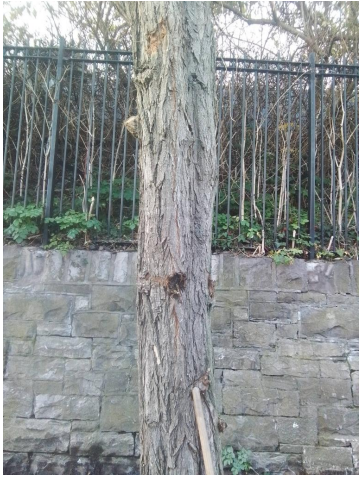
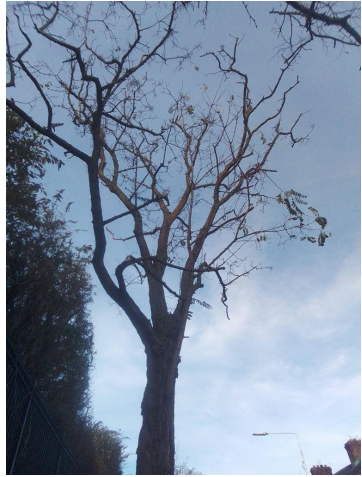
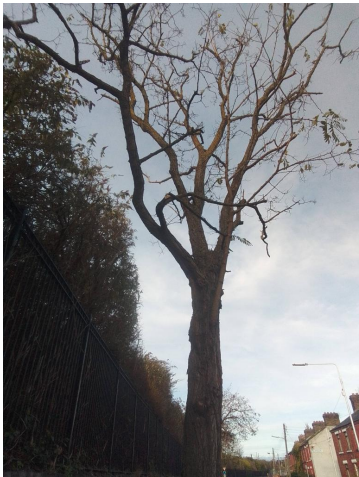
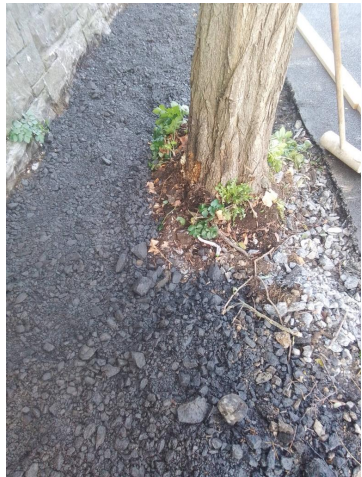
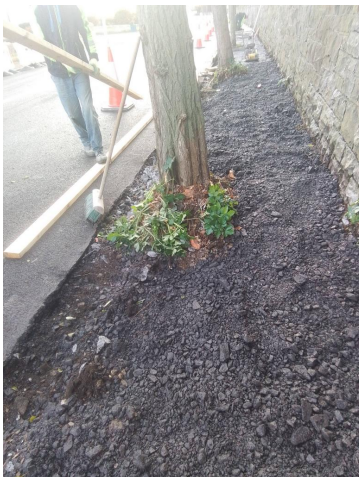
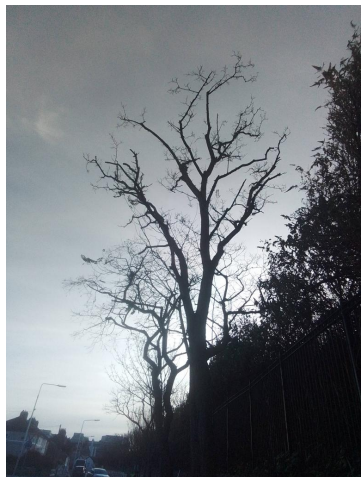
Inventory	
Surveyor	Iudovic.beaumont
Inspection Date	29-Nov-2022
Trunk Type	Single
Age	Young (Within first third of life span)
Condition	Poor (Low Vitality/Extensive Defects)
Proximity	OPPOSITE
Building Number	63
Street	West Road
Stem Diameter	21cm-25cm (@1.5m)
Spread	3-6m (Diameter)
Height	05 to 10m
Category	U - Trees with serious defect/decline
Committee	
Site	Pavement

Considerations	
Consideration	t. Dieback/Poor foliage

Considerations	
Consideration	t. Unstable rootplate

Considerations	
Consideration	t. Dead wood

Considerations	
Consideration	s. Unsuitable for Location

Requirements	
Date Added	29-Nov-2022
Priority	3b. (within 14 working days)
Requirement Type	Tree Removal
Requirement Option	
Requirement Info

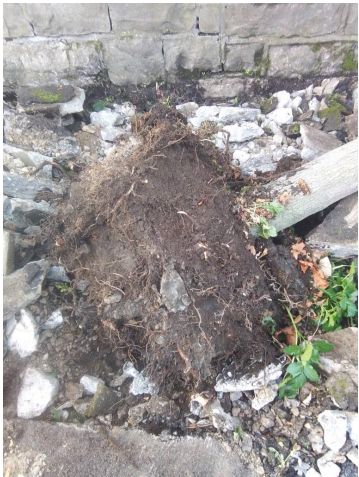
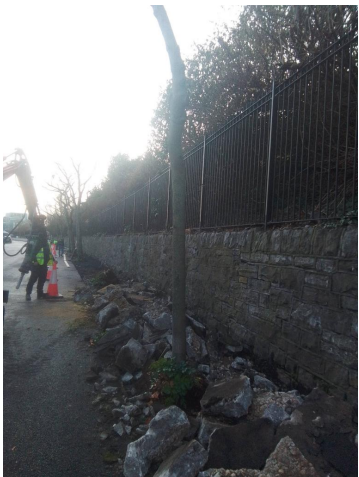
Inventory	
Surveyor	Iudovic.beaumont
Inspection Date	29-Nov-2022
Trunk Type	Single
Age	Young (Within first third of life span)
Condition	Poor (Low Vitality/Extensive Defects)
Proximity	
Building Number	56
Street	West Road
Stem Diameter	16cm-20cm (@1.5m)
Spread	3-6m (Diameter)
Height	05 to 10m
Category	U - Trees with serious defect/decline
Committee	
Site	Pavement

Considerations	
Consideration	t. Unstable rootplate

Considerations	
Consideration	s. Unsuitable for Location

Comment	
Surveyor	ludovic.beaumont
Comment Date	29-Nov-2022
Comment	Tree was moving when lightly pushed. Felled it immediately. Rootball picture shows very little structural roots growth since planted.

Requirements	
Date Added	29-Nov-2022
Priority	3b. (within 14 working days)
Requirement Type	Tree Removal
Requirement Option	
Requirement Info

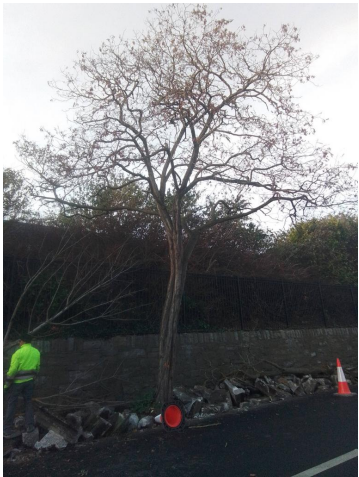
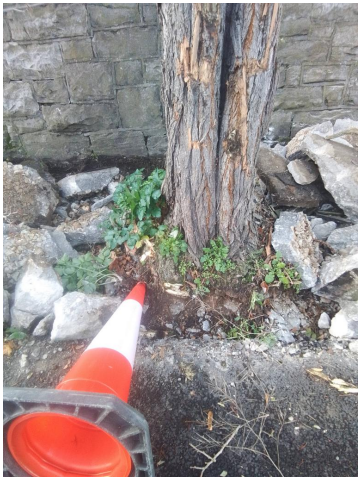
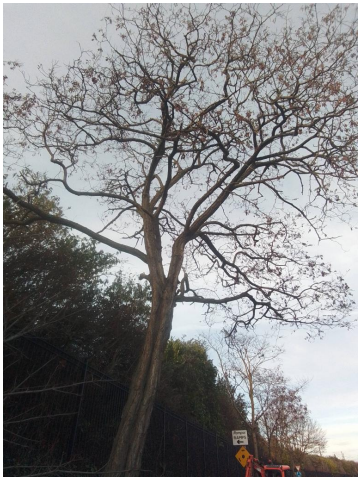
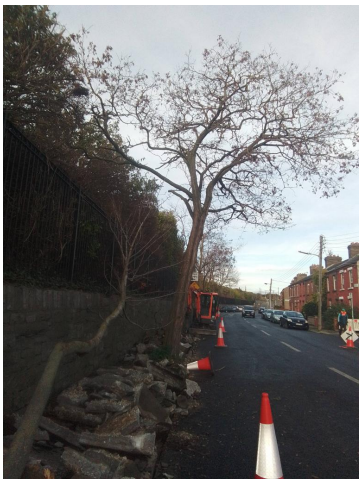
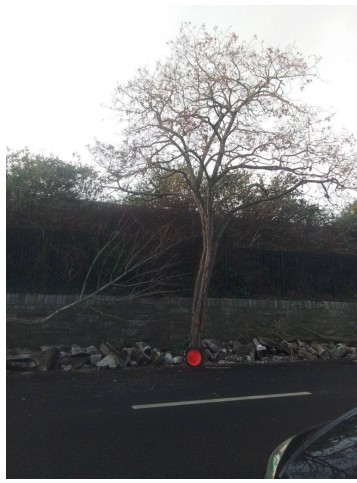
Inventory	
Surveyor	Iudovic.beaumont
Inspection Date	29-Nov-2022
Trunk Type	Single
Age	Young (Within first third of life span)
Condition	Poor (Low Vitality/Extensive Defects)
Proximity	OPPOSITE
Building Number	57
Street	West Road
Stem Diameter	36cm-40cm (@1.5m)
Spread	3-6m (Diameter)
Height	05 to 10m
Category	U - Trees with serious defect/decline
Committee	
Site	Pavement

Considerations	
Consideration	s. Unsuitable for Location

Considerations	
Consideration	t. Unstable rootplate

Considerations	
Consideration	t. Roots damaged

Considerations	
Consideration	t. Cavity/Decay Stem

Requirements	
Date Added	29-Nov-2022
Priority	3b. (within 14 working days)
Requirement Type	Tree Removal
Requirement Option	
Requirement Info

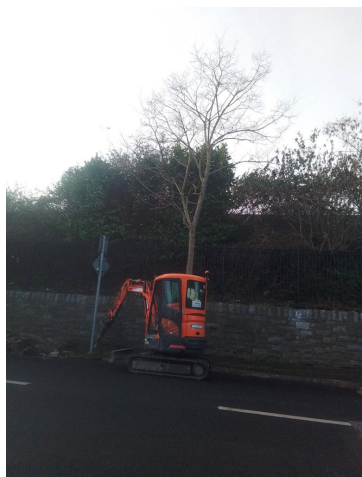
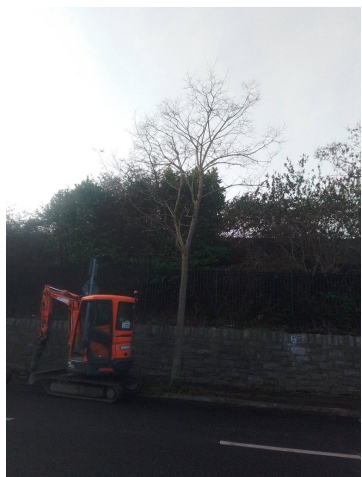
Unique ID: 09MS  
Gleditsia triacanthos

Inventory	
Surveyor	Iudovic.beaumont
Inspection Date	29-Nov-2022
Trunk Type	Single
Age	Middle Aged (Within second third of lifespan)
Condition	Poor (Low Vitality/Extensive Defects)
Proximity	OPPOSITE
Building Number	ST Barnabas Gardens
Street	West Road
Stem Diameter	36cm-40cm (@1.5m)
Spread	3-6m (Diameter)
Height	05 to 10m
Category	U - Trees with serious defect/decline
Committee	
Site	Tarmac

Considerations	
Consideration	t. Unstable rootplate

Considerations	
Consideration	s. Unsuitable for Location

Requirements	
Date Added	29-Nov-2022
Priority	3b. (within 14 working days)
Requirement Type	Tree Removal
Requirement Option	
Requirement Info

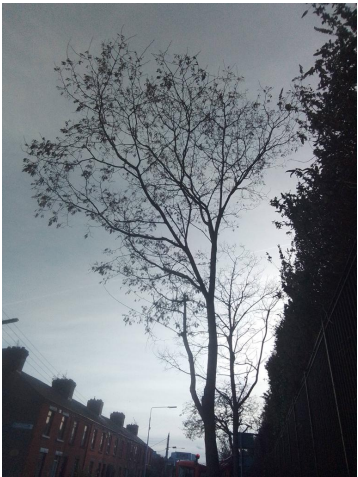
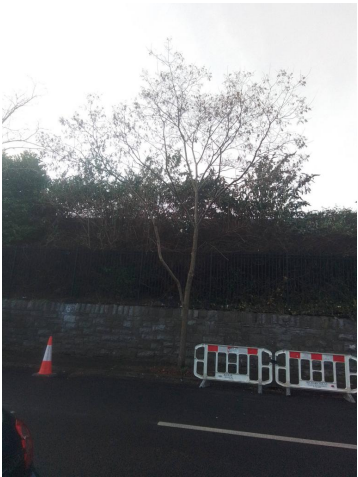
Inventory	
Surveyor	Iudovic.beaumont
Inspection Date	29-Nov-2022
Trunk Type	Single
Age	Middle Aged (Within second third of lifespan)
Condition	Poor (Low Vitality/Extensive Defects)
Proximity	OPPOSITE
Building Number	55
Street	West Road
Stem Diameter	31cm-35cm (@1.5m)
Spread	3-6m (Diameter)
Height	05 to 10m
Category	U - Trees with serious defect/decline
Committee	
Site	Tarmac

Considerations	
Consideration	t. Unstable rootplate

Considerations	
Consideration	s. Unsuitable for Location

Requirements	
Date Added	29-Nov-2022
Priority	3b. (within 14 working days)
Requirement Type	Tree Removal
Requirement Option	
Requirement Info

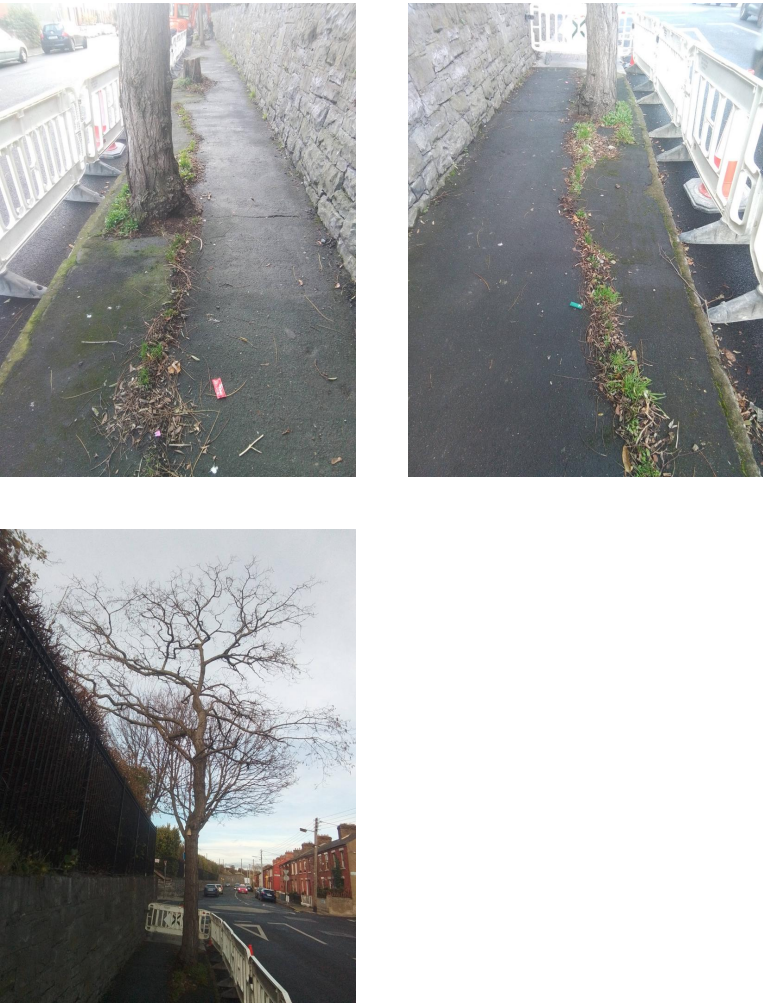
Inventory	
Surveyor	Iudovic.beaumont
Inspection Date	29-Nov-2022
Trunk Type	Single
Age	Middle Aged (Within second third of lifespan)
Condition	Poor (Low Vitality/Extensive Defects)
Proximity	OPPOSITE
Building Number	50
Street	West Road
Stem Diameter	31cm-35cm (@1.5m)
Spread	3-6m (Diameter)
Height	05 to 10m
Category	U - Trees with serious defect/decline
Committee	
Site	Tarmac

Considerations	
Consideration	t. Unstable rootplate

Requirements	
Date Added	29-Nov-2022
Priority	3b. (within 14 working days)
Requirement Type	Tree Removal
Requirement Option	
Requirement Info

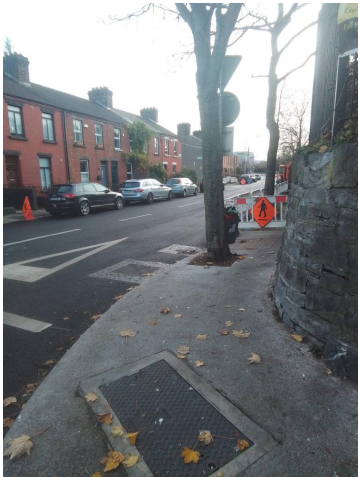
Inventory	
Surveyor	Iudovic.beaumont
Inspection Date	29-Nov-2022
Trunk Type	Single
Age	Middle Aged (Within second third of lifespan)
Condition	Poor (Low Vitality/Extensive Defects)
Proximity	OPPOSITE
Building Number	49
Street	West Road
Stem Diameter	36cm-40cm (@1.5m)
Spread	3-6m (Diameter)
Height	10 to 15m
Category	U - Trees with serious defect/decline
Committee	
Site	Tarmac

Considerations	
Consideration	t. Damage to roots

Considerations	
Consideration	s. Unsuitable for Location

Requirements	
Date Added	29-Nov-2022
Priority	3b. (within 14 working days)
Requirement Type	Tree Removal
Requirement Option	
Requirement Info
