# Tree Inventory Report

Dublin City Council

29 November 2022

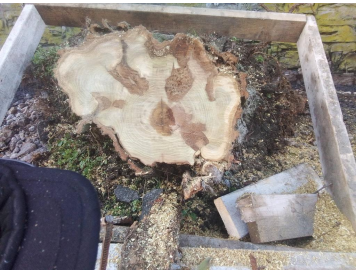
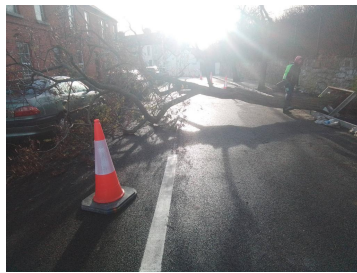
Inventory	
Surveyor	Iudovic.beaumont
Inspection Date	29-Nov-2022
Trunk Type	Single
Age	Middle Aged (Within second third of lifespan)
Condition	Felled
Proximity	
Street	West Road
Stem Diameter	36cm-40cm (@1.5m)
Spread	3-6m (Diameter)
Height	05 to 10m
Category	U - Trees with serious defect/decline
Committee	
Site	Tarmac

Comment	
Surveyor	ludovic.beaumont
Comment Date	29-Nov-2022
Comment	Main root on wall side had totally decayed.

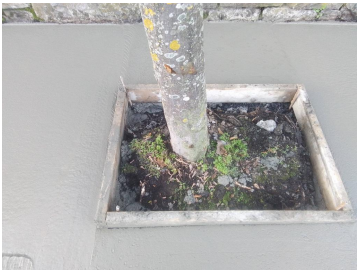
Inventory	
Surveyor	Iudovic.beaumont
Inspection Date	29-Nov-2022
Trunk Type	Single
Age	Young (Within first third of life span)
Condition	Poor (Low Vitality/Extensive Defects)
Proximity	
Building Number	Roundabout
Street	West Road
Stem Diameter	21cm-25cm (@1.5m)
Spread	3-6m (Diameter)
Height	05 to 10m
Category	U - Trees with serious defect/decline
Committee	
Site	Pavement

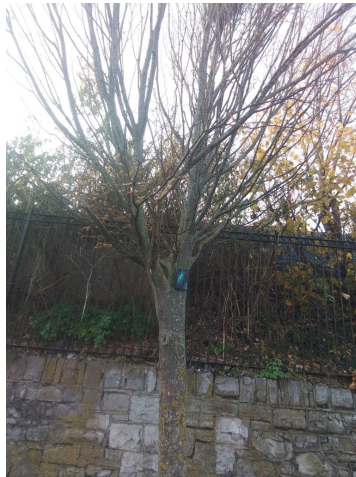
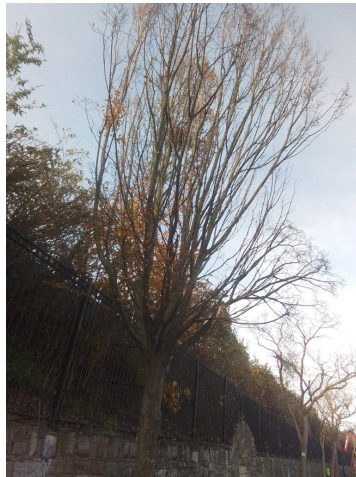
Inventory	
Surveyor	ludovic.beaumont
Inspection Date	29-Nov-2022
Trunk Type	Single
Age	Young (Within first third of life span)
Condition	Poor (Low Vitality/Extensive Defects)
Proximity	
Building Number	ROUNDAABOUT
Street	West Road
Stem Diameter	21cm-25cm (@1.5m)
Spread	3-6m (Diameter)
Height	05 to 10m
Category	U - Trees with serious defect/decline
Committee	
Site	Pavement

Considerations	
Consideration	t. Crack on Limb

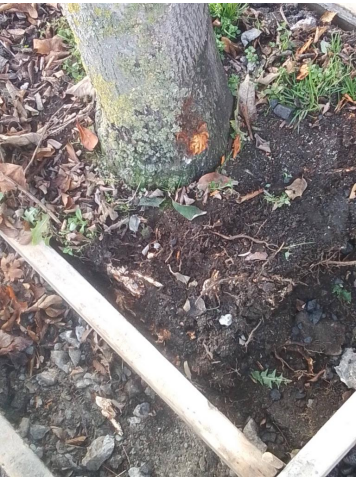
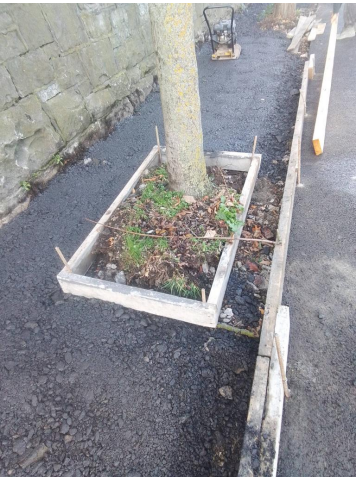
Inventory	
Surveyor	Iudovic.beaumont
Inspection Date	29-Nov-2022
Trunk Type	Single
Age	Young (Within first third of life span)
Condition	Poor (Low Vitality/Extensive Defects)
Proximity	OPPOSITE
Building Number	64
Street	West Road
Stem Diameter	21cm-25cm (@1.5m)
Spread	3-6m (Diameter)
Height	05 to 10m
Category	U - Trees with serious defect/decline
Committee	
Site	Pavement

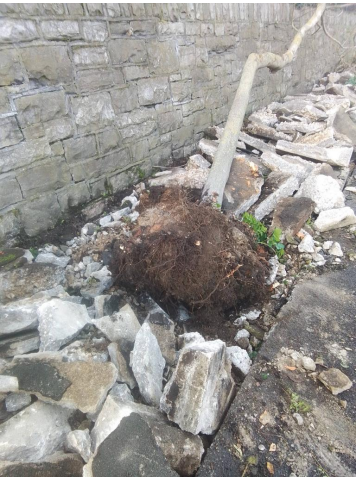
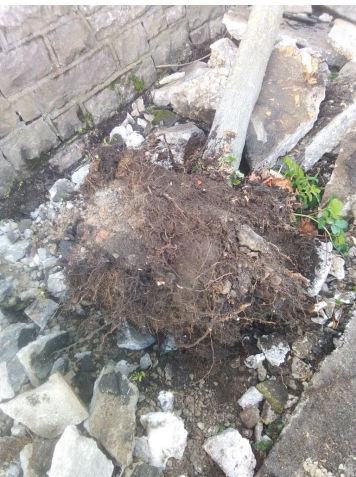
Inventory	
Surveyor	Iudovic.beaumont
Inspection Date	29-Nov-2022
Trunk Type	Single
Age	Young (Within first third of life span)
Condition	Poor (Low Vitality/Extensive Defects)
Proximity	
Building Number	56
Street	West Road
Stem Diameter	16cm-20cm (@1.5m)
Spread	3-6m (Diameter)
Height	05 to 10m
Category	U - Trees with serious defect/decline
Committee	
Site	Pavement

Comment	
Surveyor	ludovic.beaumont
Comment Date	29-Nov-2022
Comment	Tree was moving when lightly pushed. Felled it immediately. Rootball picture shows very little structural roots growth since planted.

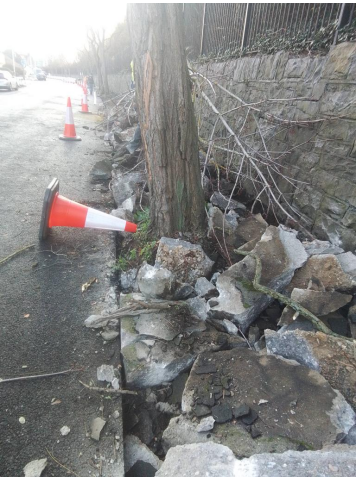
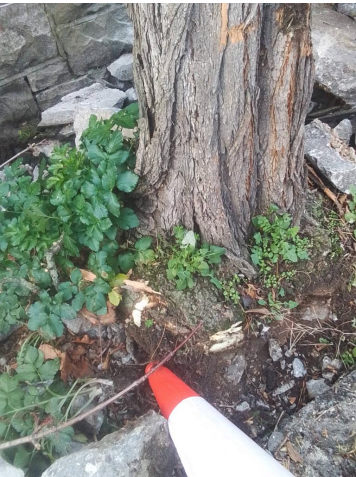
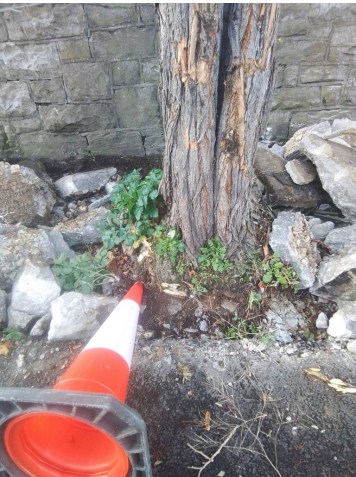
Inventory	
Surveyor	Iudovic.beaumont
Inspection Date	29-Nov-2022
Trunk Type	Single
Age	Young (Within first third of life span)
Condition	Poor (Low Vitality/Extensive Defects)
Proximity	OPPOSITE
Building Number	57
Street	West Road
Stem Diameter	36cm-40cm (@1.5m)
Spread	3-6m (Diameter)
Height	05 to 10m
Category	U - Trees with serious defect/decline
Committee	
Site	Pavement

Considerations	
Consideration	t. Roots damaged

Considerations	
Consideration	t. Cavity/Decay Stem

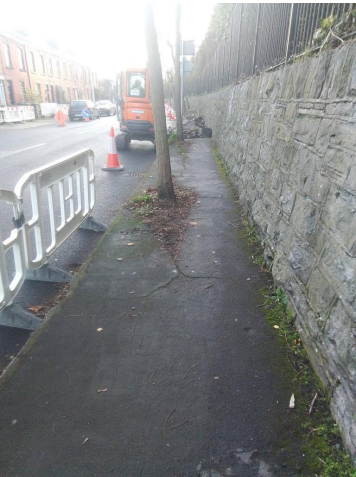
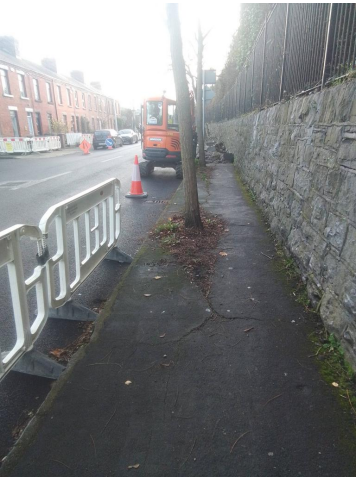
Inventory	
Surveyor	Iudovic.beaumont
Inspection Date	29-Nov-2022
Trunk Type	Single
Age	Middle Aged (Within second third of lifespan)
Condition	Poor (Low Vitality/Extensive Defects)
Proximity	OPPOSITE
Building Number	55
Street	West Road
Stem Diameter	31cm-35cm (@1.5m)
Spread	3-6m (Diameter)
Height	05 to 10m
Category	U - Trees with serious defect/decline
Committee	
Site	Tarmac

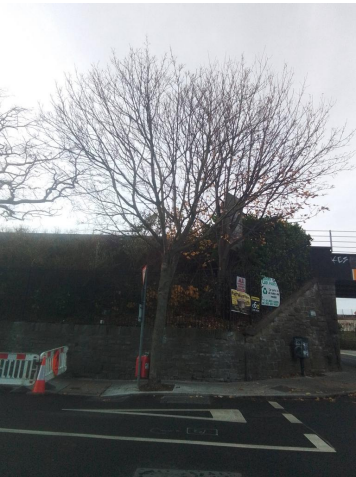
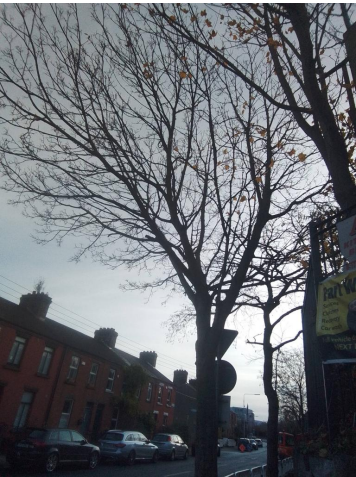
Inventory	
Surveyor	Iudovic.beaumont
Inspection Date	29-Nov-2022
Trunk Type	Single
Age	Middle Aged (Within second third of lifespan)
Condition	Poor (Low Vitality/Extensive Defects)
Proximity	OPPOSITE
Building Number	49
Street	West Road
Stem Diameter	36cm-40cm (@1.5m)
Spread	3-6m (Diameter)
Height	10 to 15m
Category	U - Trees with serious defect/decline
Committee	
Site	Tarmac

Considerations	
Consideration	t. Damage to roots
